EASTON RESERVOIR DAM
CT 00020

PHASE I INSPECTION REPORT
NATIONAL DAM INSPECTION PROGRAM

SEPTEMBER 1978

Date of Inspection: 2 AUGUST 1978

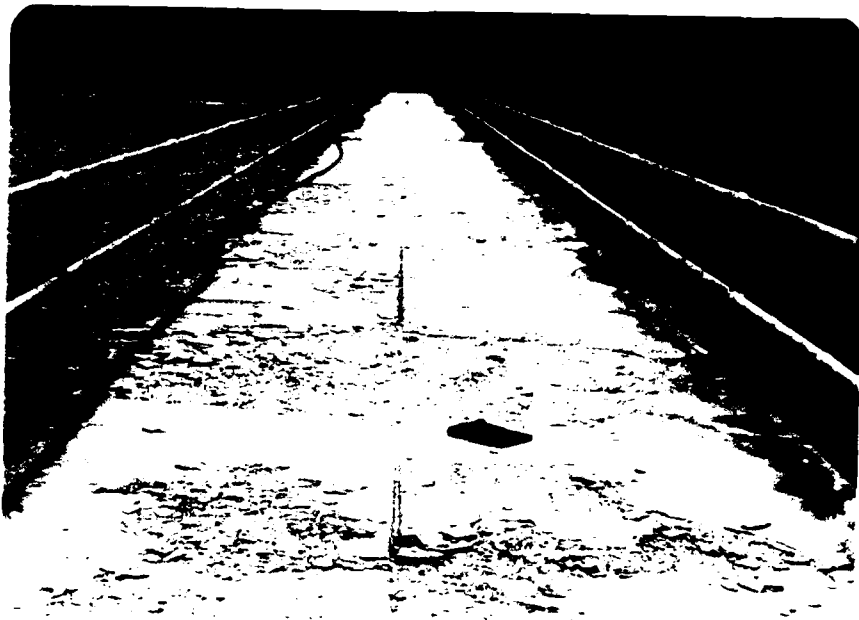
2) Top of Dam - The top surface of the dam for nearly the full length has many areas of surface spalling, joint spalling and general deterioration. The coping has deteriorated and spalled at several areas west of the gatehouse. To the east of the gatehouse, the lip at both the upstream and downstream face, for nearly the entire length, has deteriorated and spalled. At about Station 7+15, the lip has deteriorated to such an extent that the anchorage for the post of the railing has completely pulled away from the concrete.

PHOTO #5: View along crest of dam, looking east.

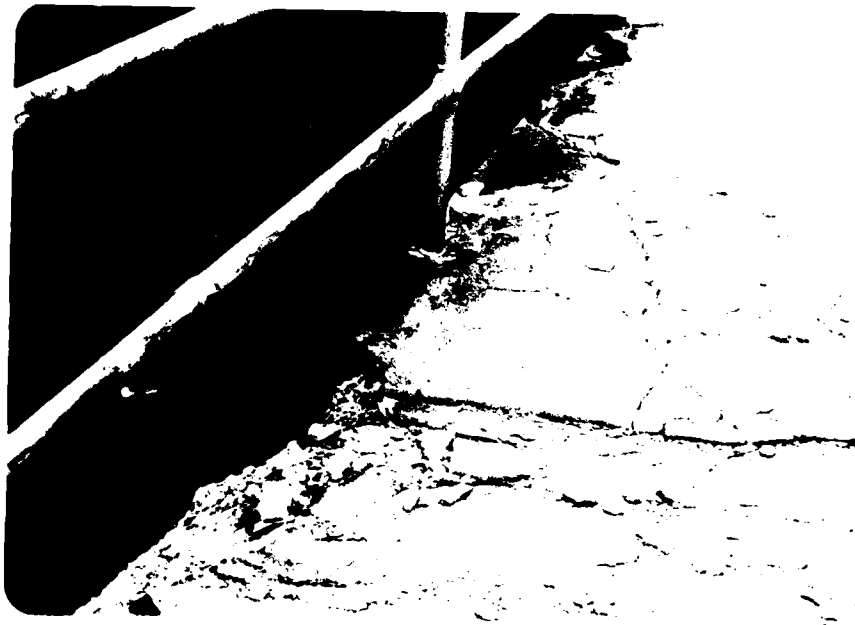
PHOTO #6: Typical concrete surface conditions along edge and top of crest.

a. Concrete surfaces of downstream face and top of dam affected by spalling should be repaired.

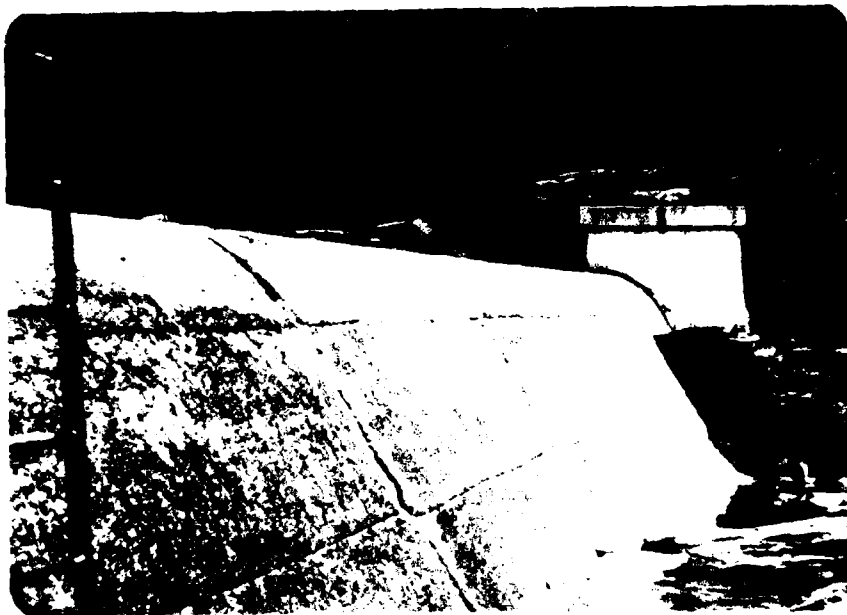
4) Spillway - The spillway is in good condition. There is some horizontal scouring of concrete, exposing the aggregate, at about 4 feet down from the crest of the spillway between Station 9+40 to Station 9+70. At the spillway section adjacent to the dam there is a wet spot several feet long at a horizontal pour joint about 5 feet down from the top of spillway. There is some joint spalling at the vertical construction joint at Station 9+70. There is some slight spalling of the downstream face beyond Station 9+90. At about Station 9+80 at the crest of the spillway there is an area about 2 feet long and several inches deep that has deteriorated and spalled off.

PHOTO #9: Downstream face of the spillway, looking east.

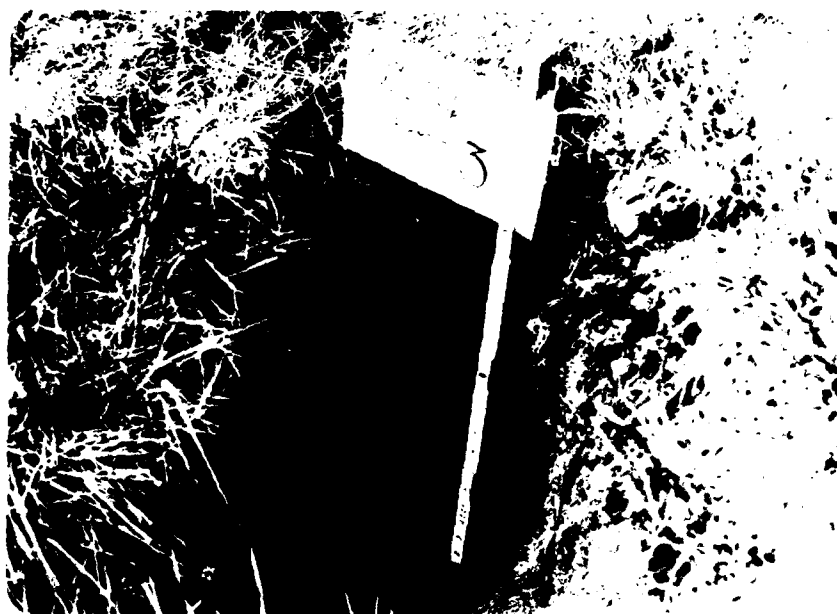
PHOTO #12: Borrow hole in earth embankment.
